## SMOKY LAKE COUNTY

**A G E N D A:** County Council Budget Meeting to be held on  
**Thursday, September 15<sup>th</sup>, 2021, at 9:00 A.M.,**  
in the County Council Chambers, Smoky Lake.

**Various County Road Failures  
Smoky Lake County, Alberta**

This report presents the results of the geotechnical investigation conducted for various county road failures within Smoky Lake County, Alberta. The work was carried out by SolidEarth Geotechnical Inc. (SolidEarth) at the authorization of Mr. Gene Sobolewski (CAO), C.E.T. of Smoky Lake County (County).

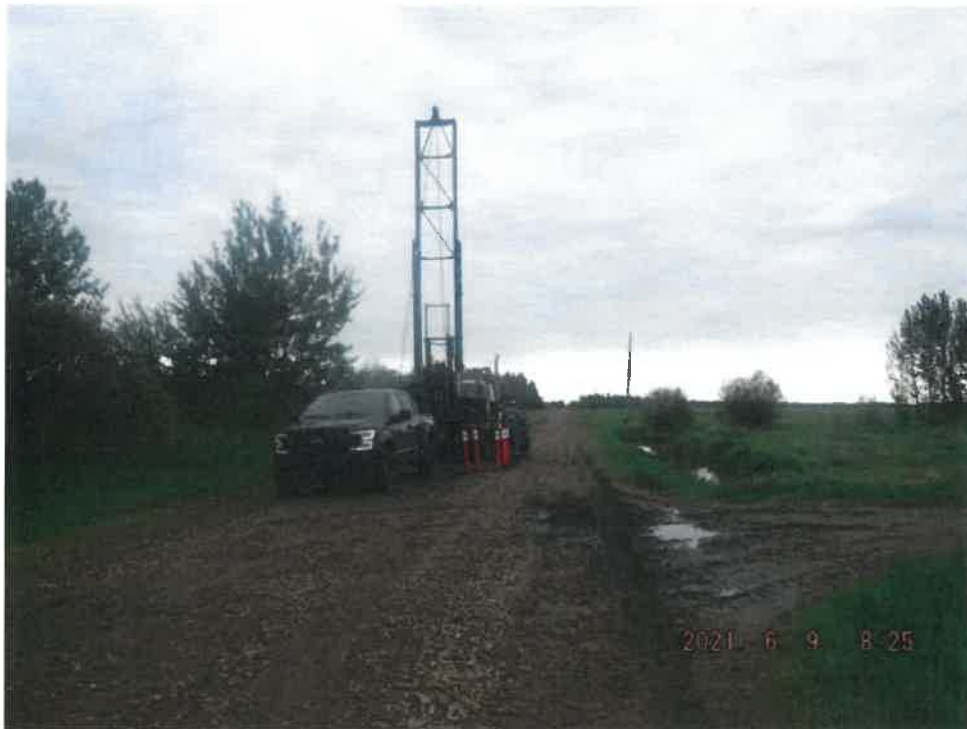
**Photograph 1: Looking north at BH21-01A within Alignment 1**

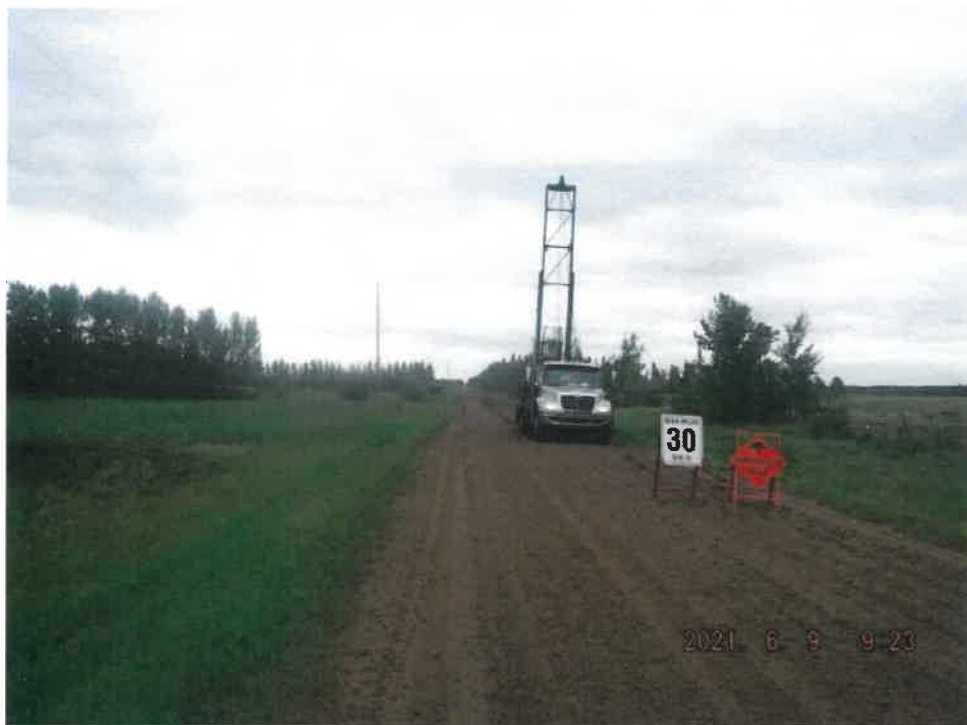
**Photograph 2: Looking south at BH21-01C within Alignment 1**

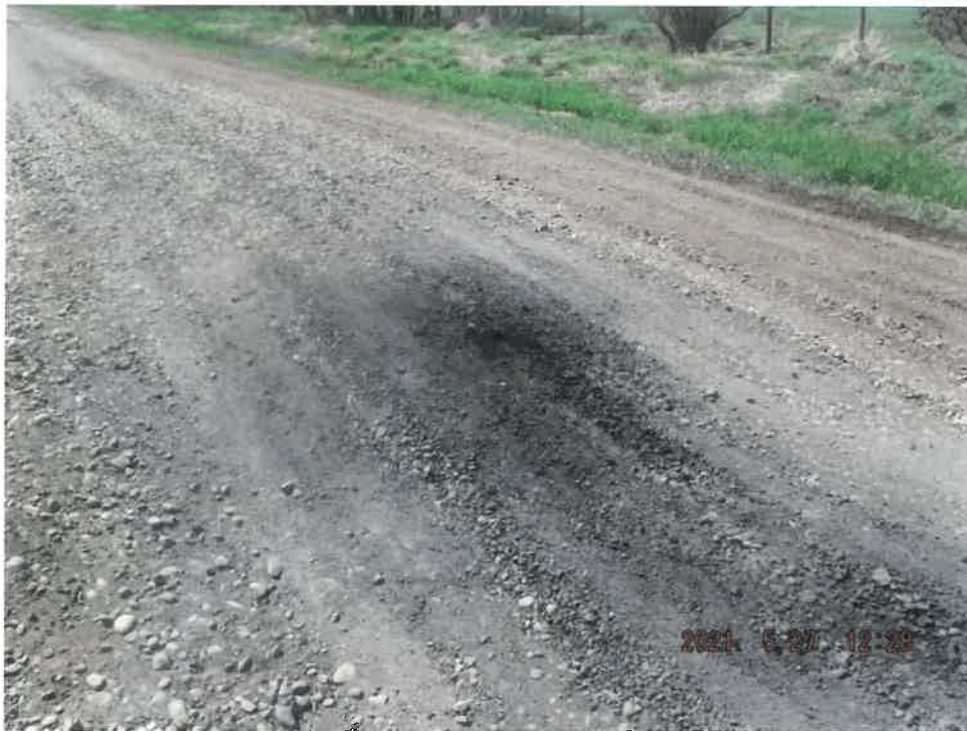
**Photograph 3: Looking at exposed organic soil within Alignment 1**

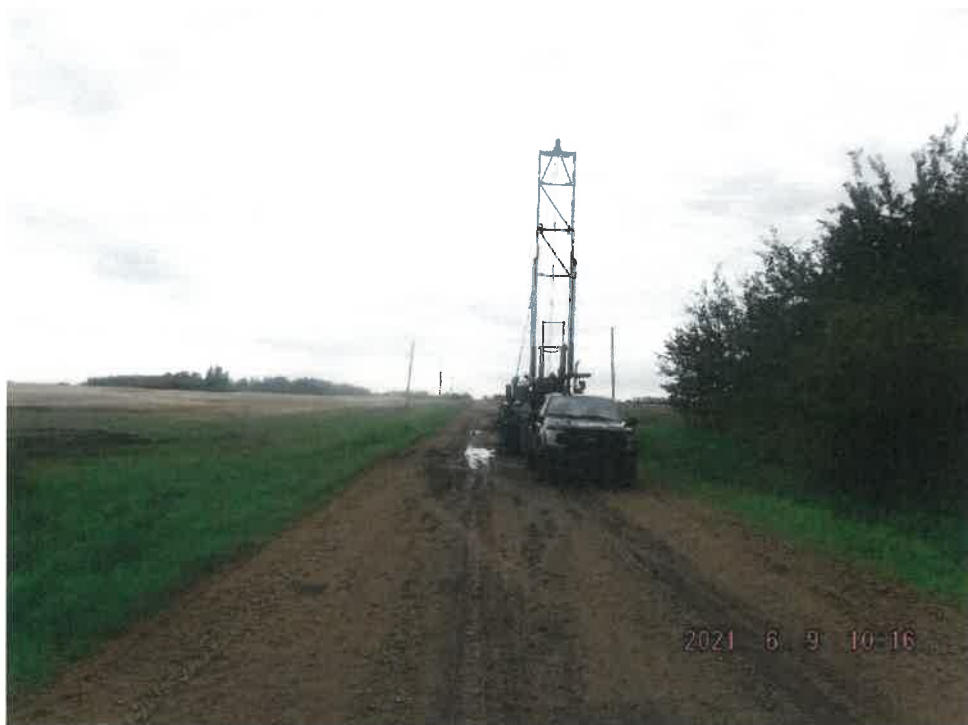
**Photograph 4: Looking east towards BH21-02A within Alignment 2**

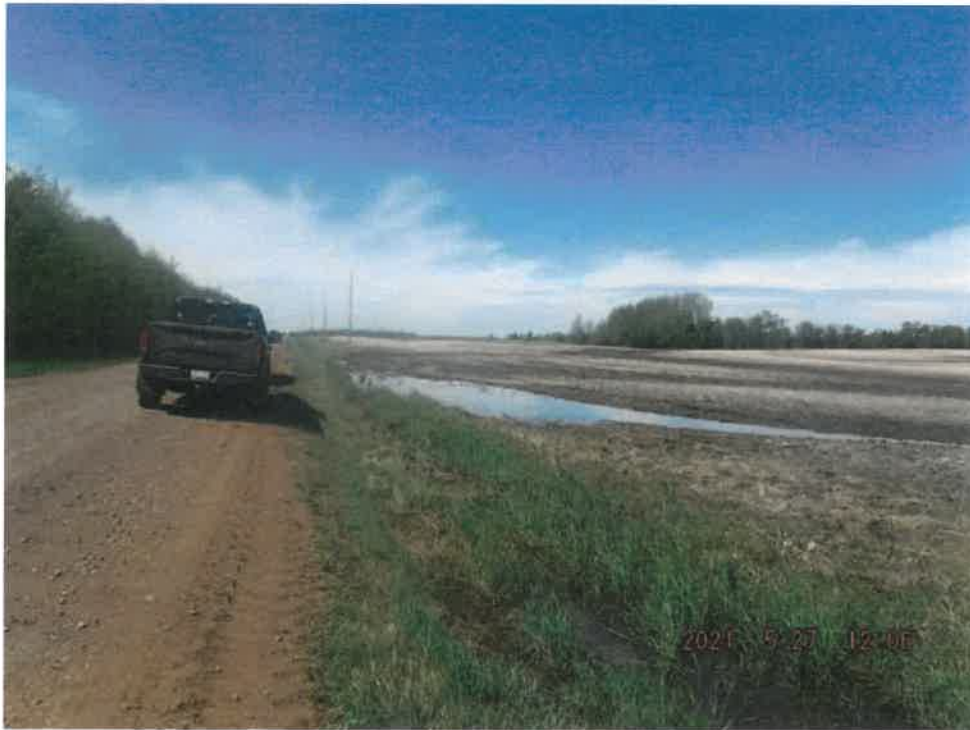
**Photograph 5: Looking west along Alignment 2.**

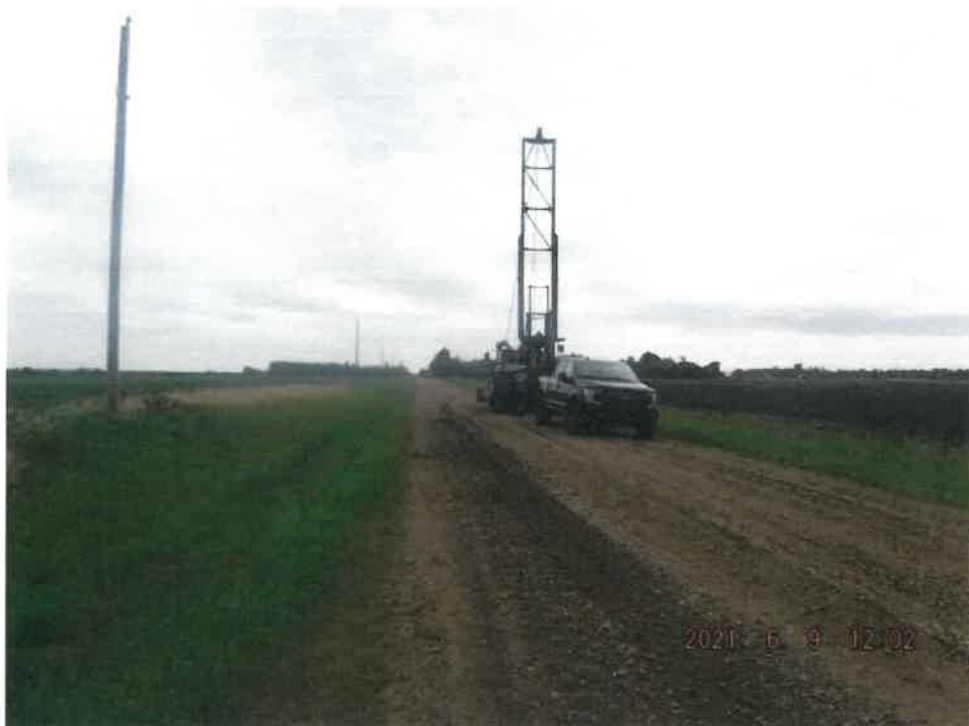
**Photograph 6: Looking east towards BH21-03A within Alignment 3**

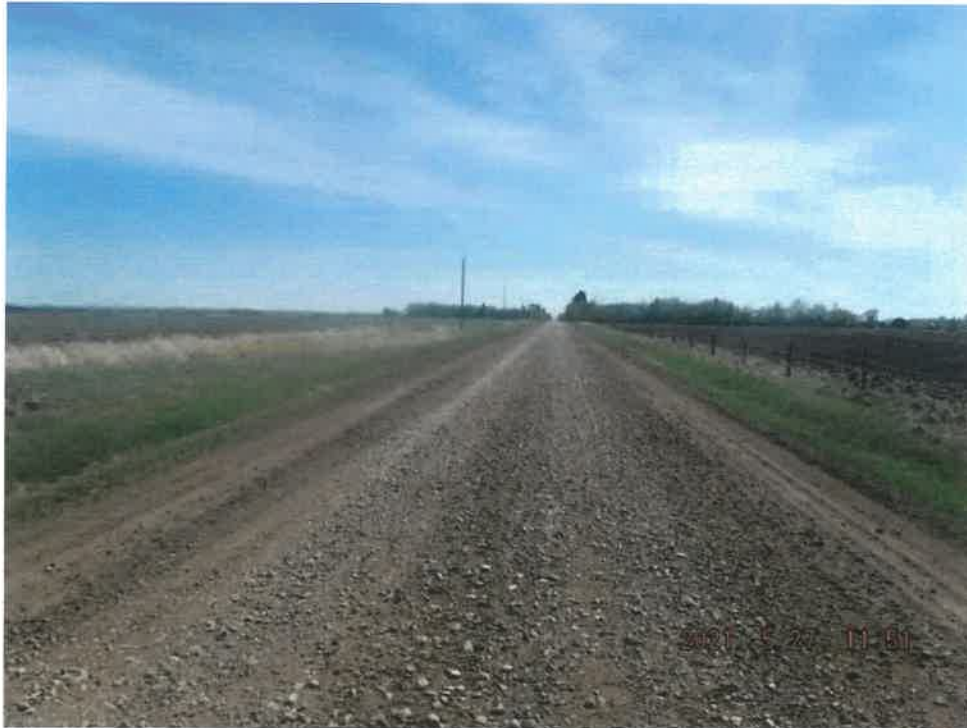
**Photograph 7: Looking east along Alignment 3.**

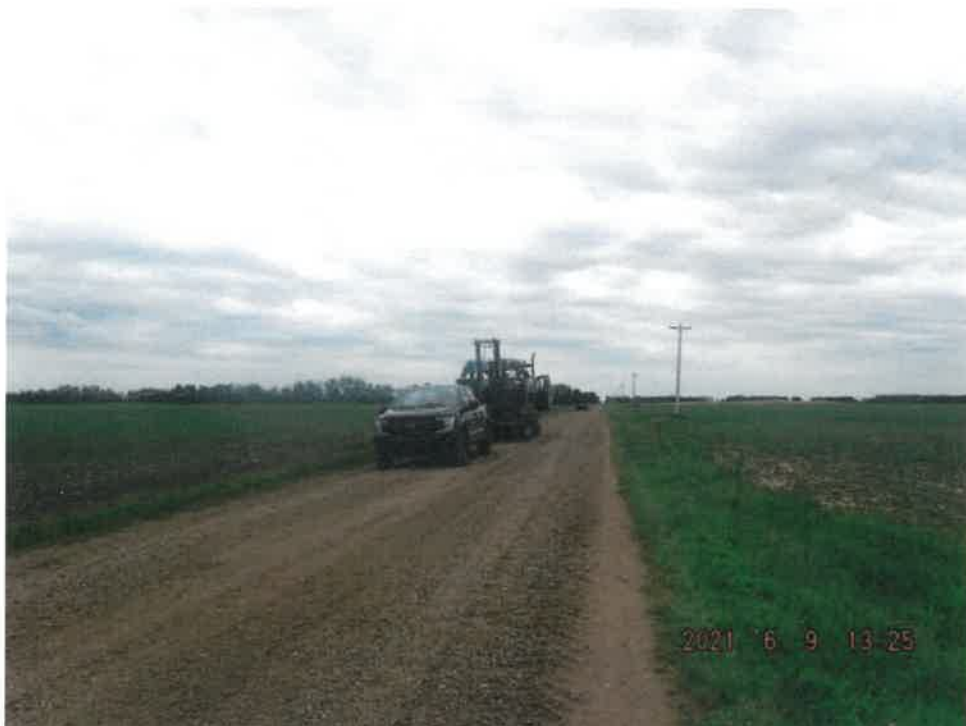
**Photograph 8: Looking south towards BH21-04A within Alignment 4**

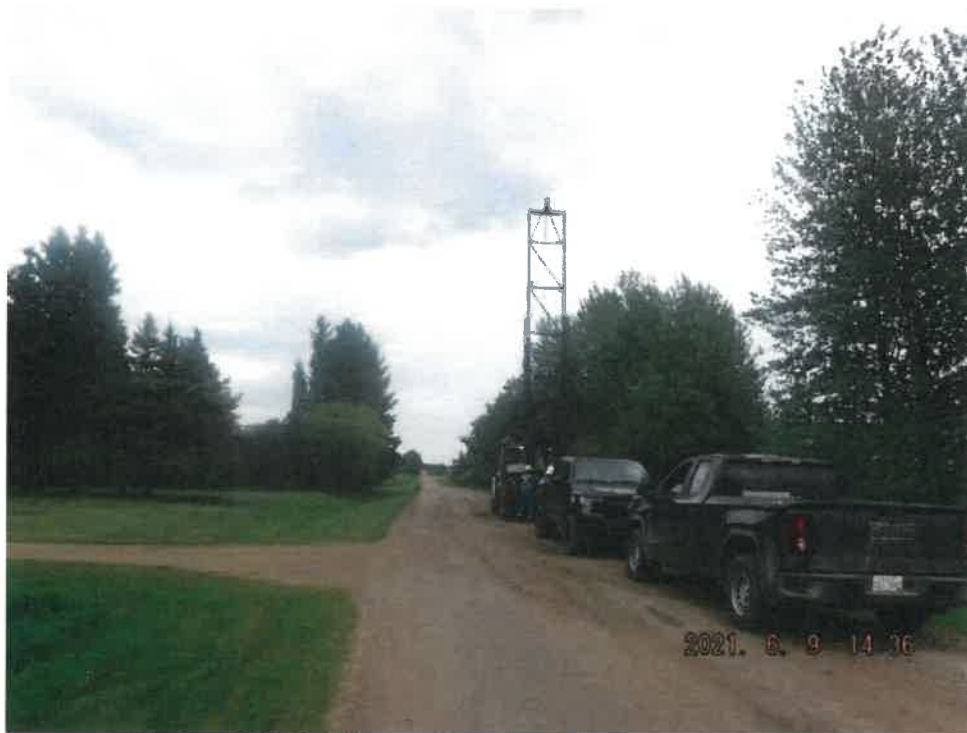
**Photograph 9: Looking east towards BH21-05A within Alignment 5**

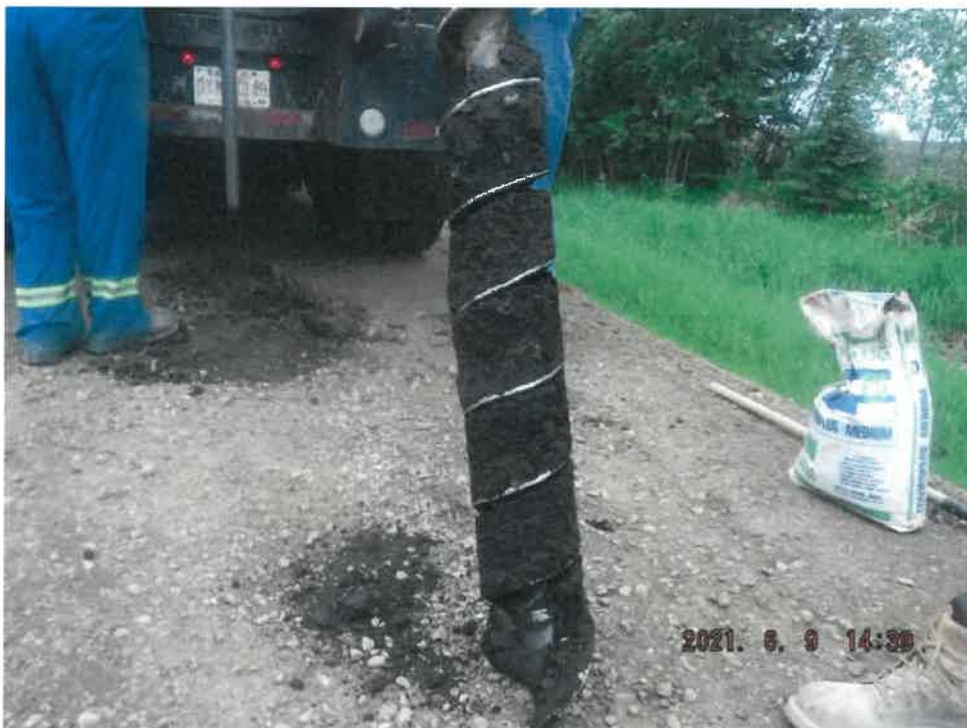
**Photograph 10: Looking at the organics at BH21-05A within Alignment 5**

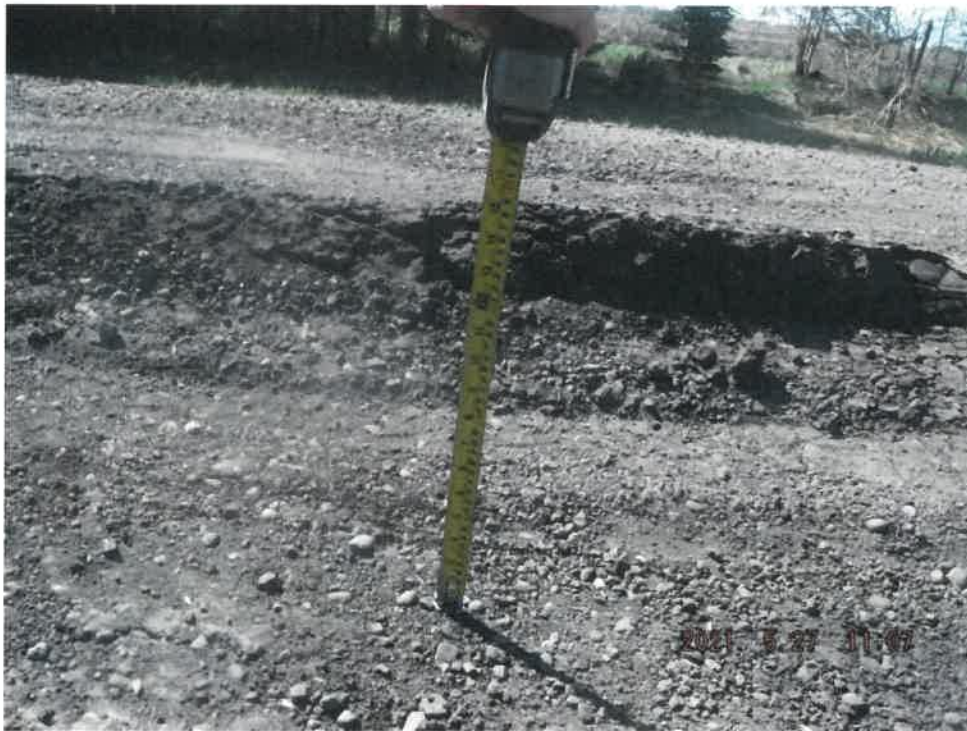
**Photograph 11: Looking at ruts within Alignment 5**

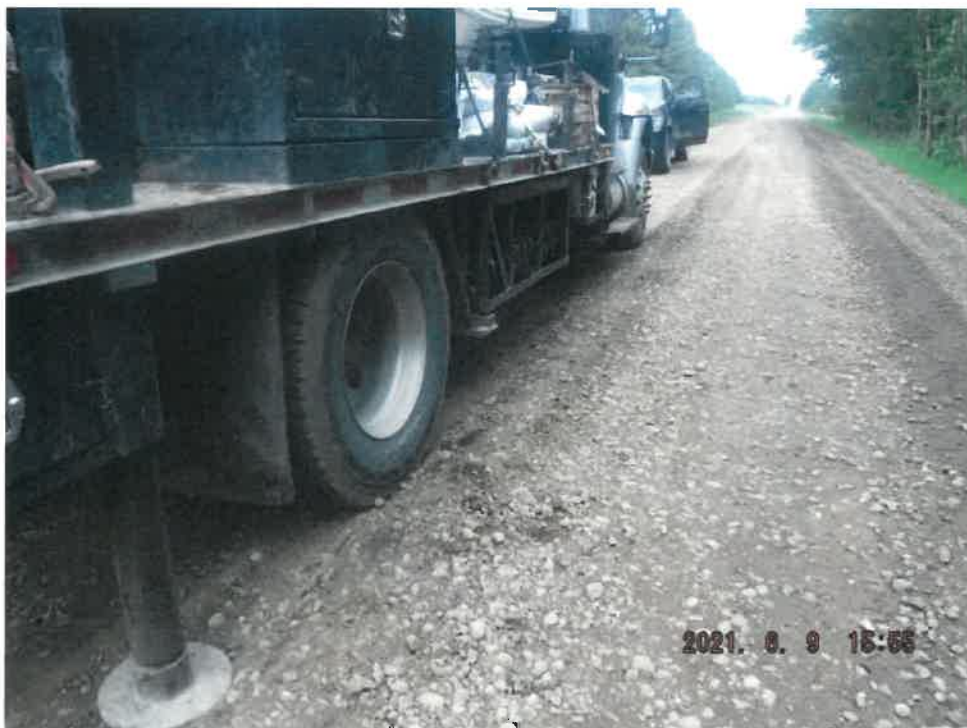
**Photograph 12: Looking towards BH21-06A within Alignment 6**

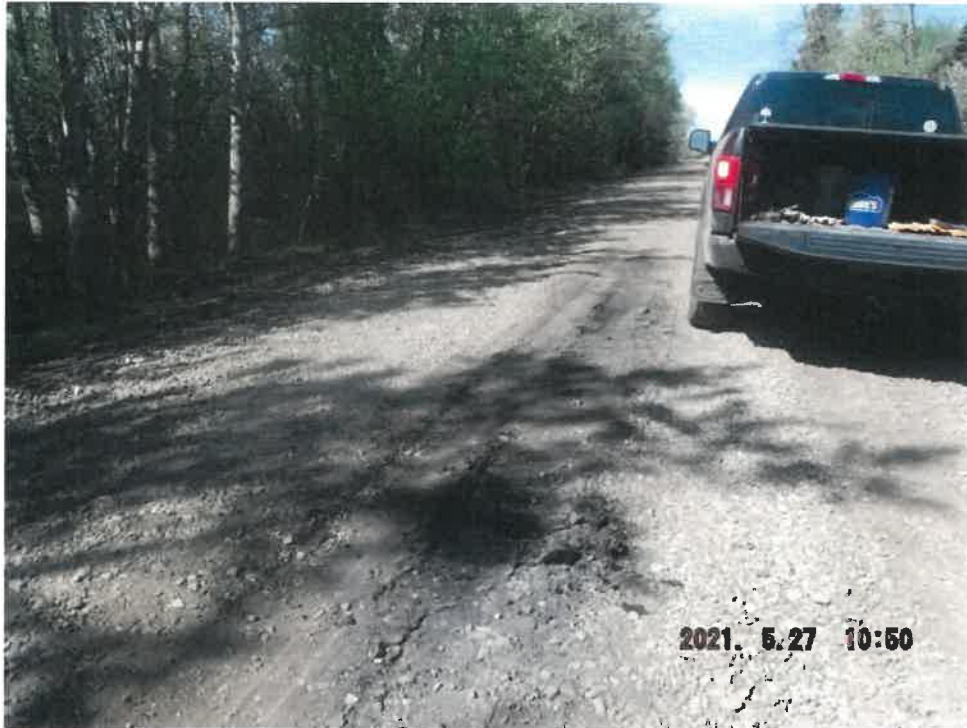
**Photograph 13: Looking at the ruts within Alignment 6**

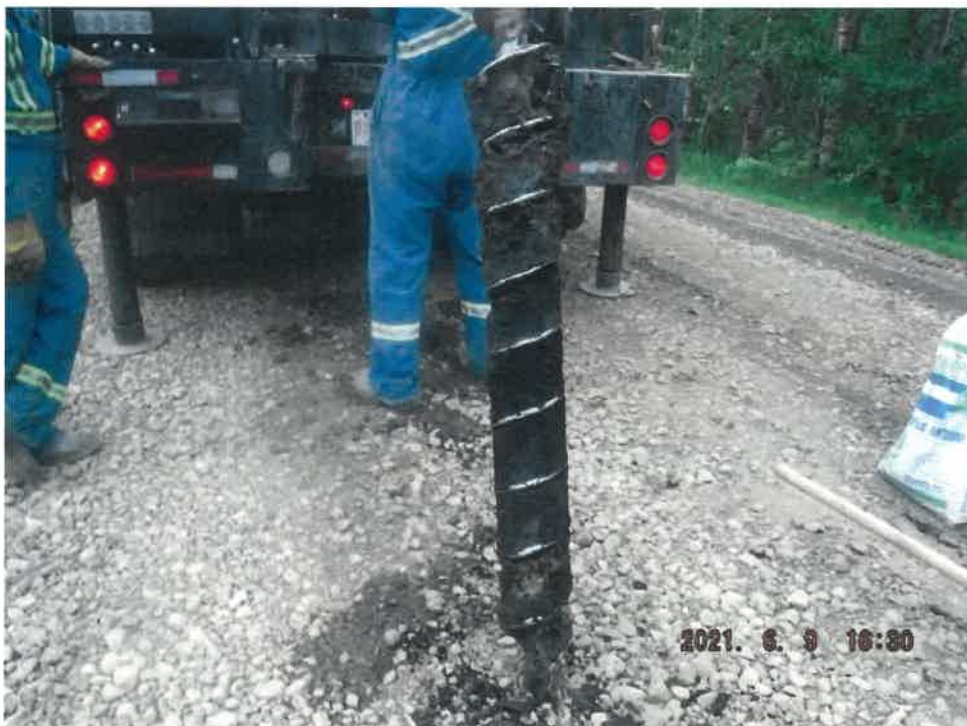
**Photograph 14: Looking at the organics at BH21-06B within Alignment 6**

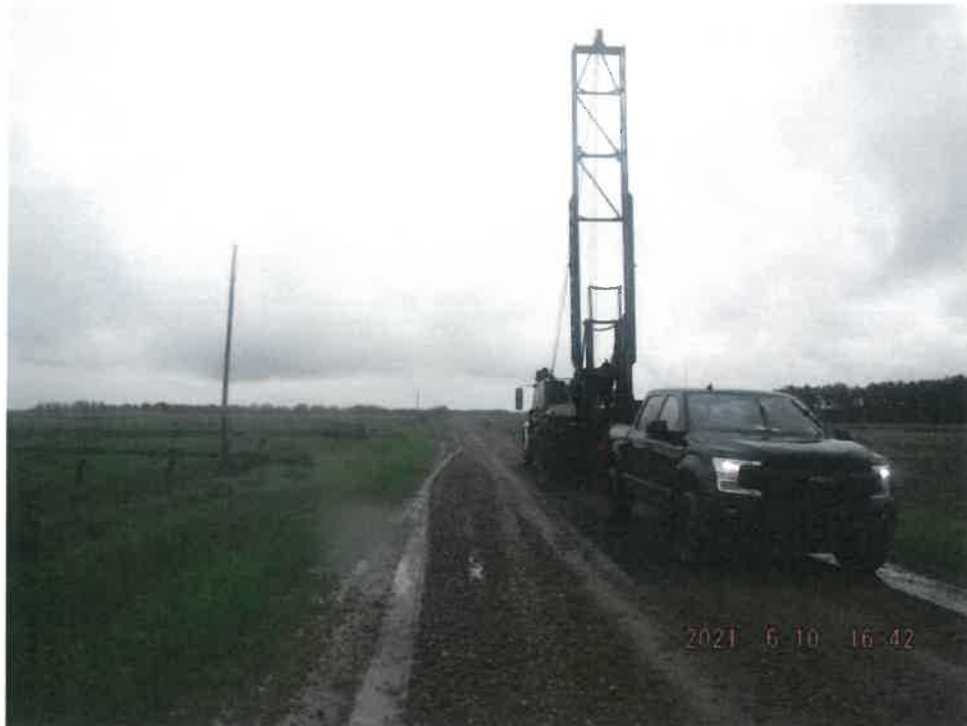
**Photograph 15: Looking north towards BH21-07B within Alignment 7**

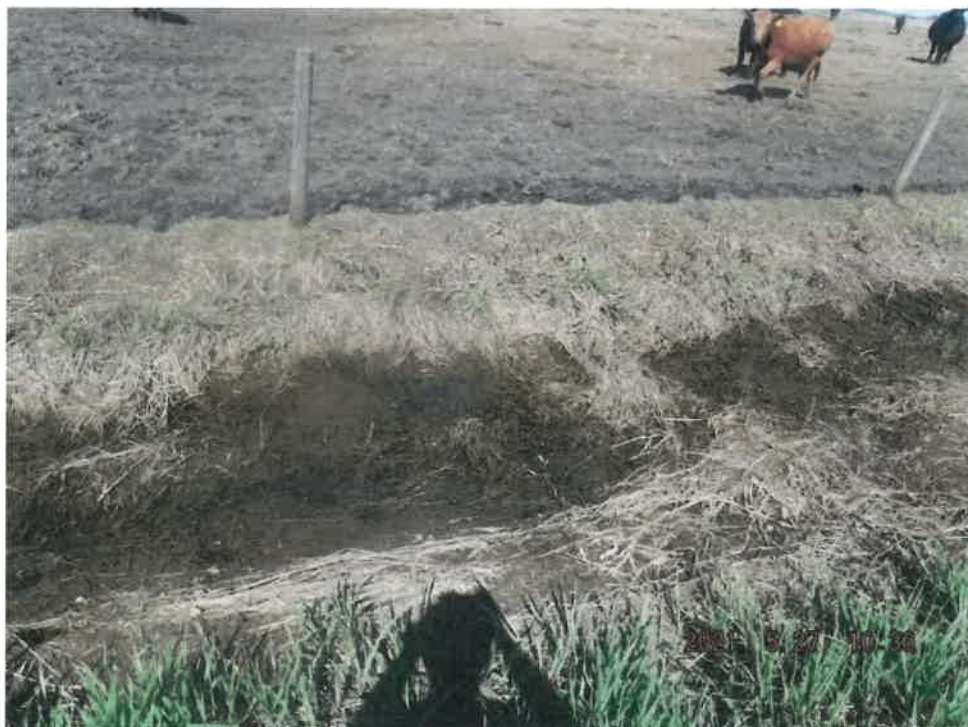
**Photograph 16: Looking at the west ditch within Alignment 7**

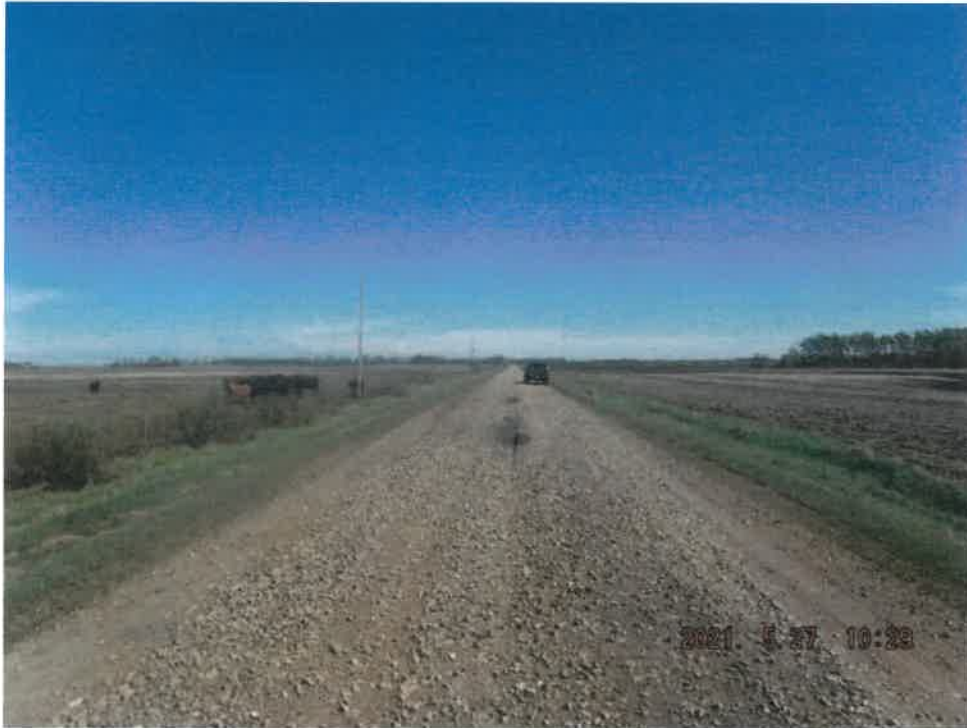
**Photograph 17: Looking north along Alignment 7**

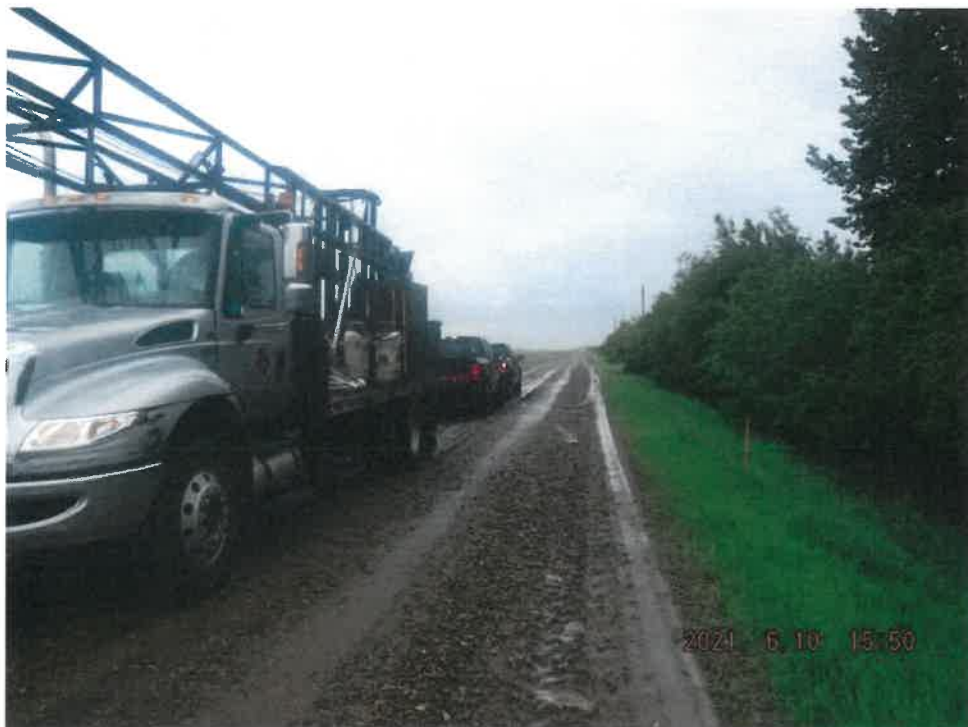
**Photograph 18: Looking south towards BH21-08C within Alignment 8**

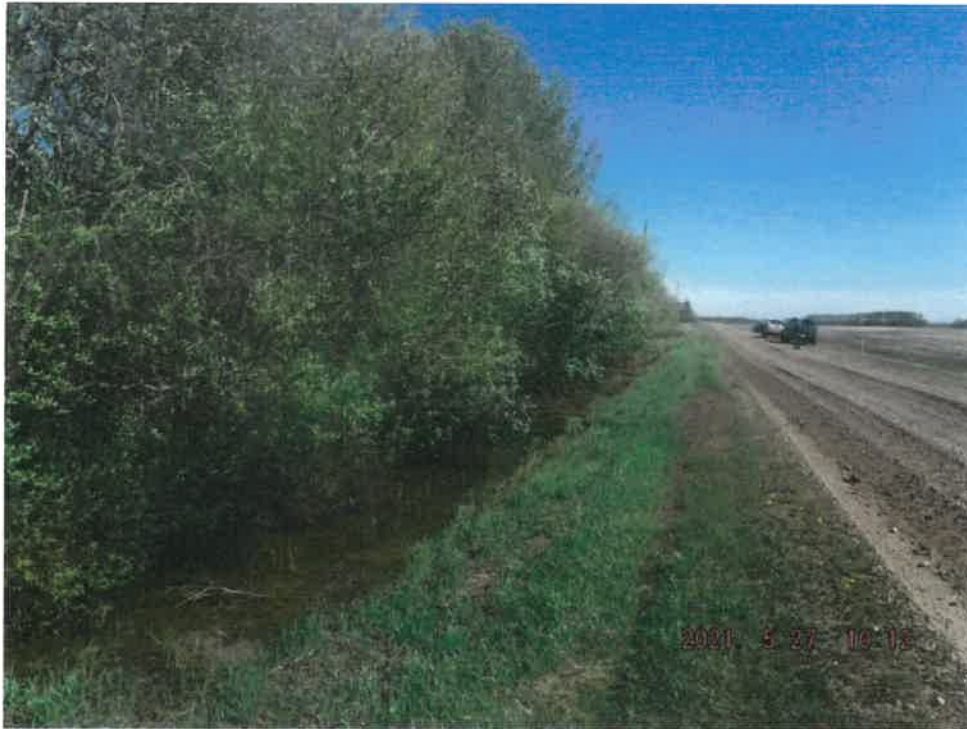
**Photograph 19: Looking north along the ditch within Alignment 8**

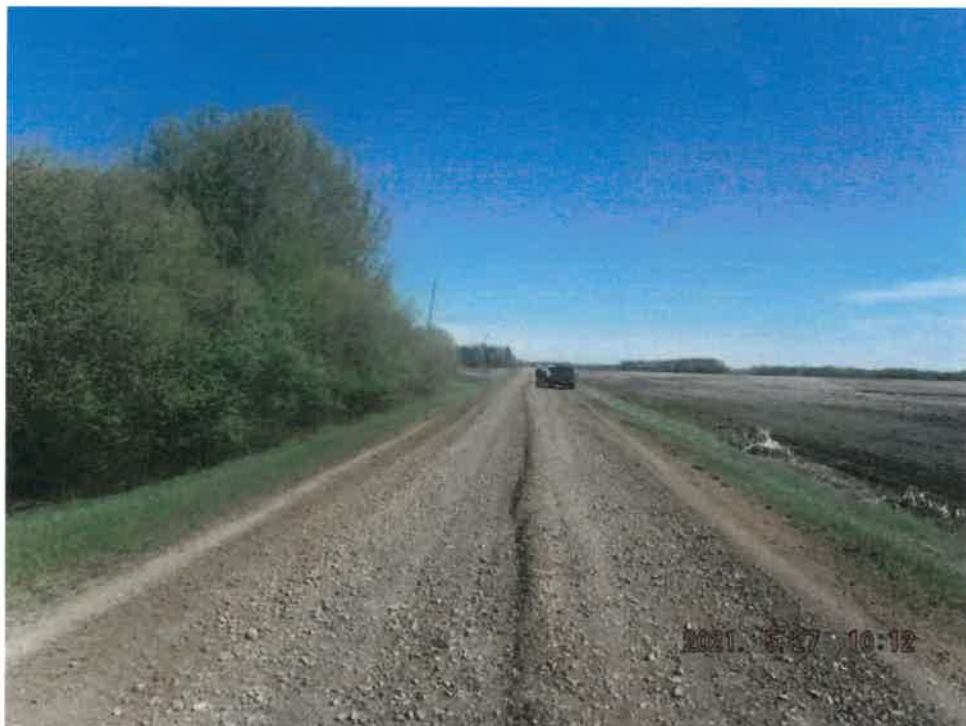
**Photograph 20: Looking north along Alignment 8**

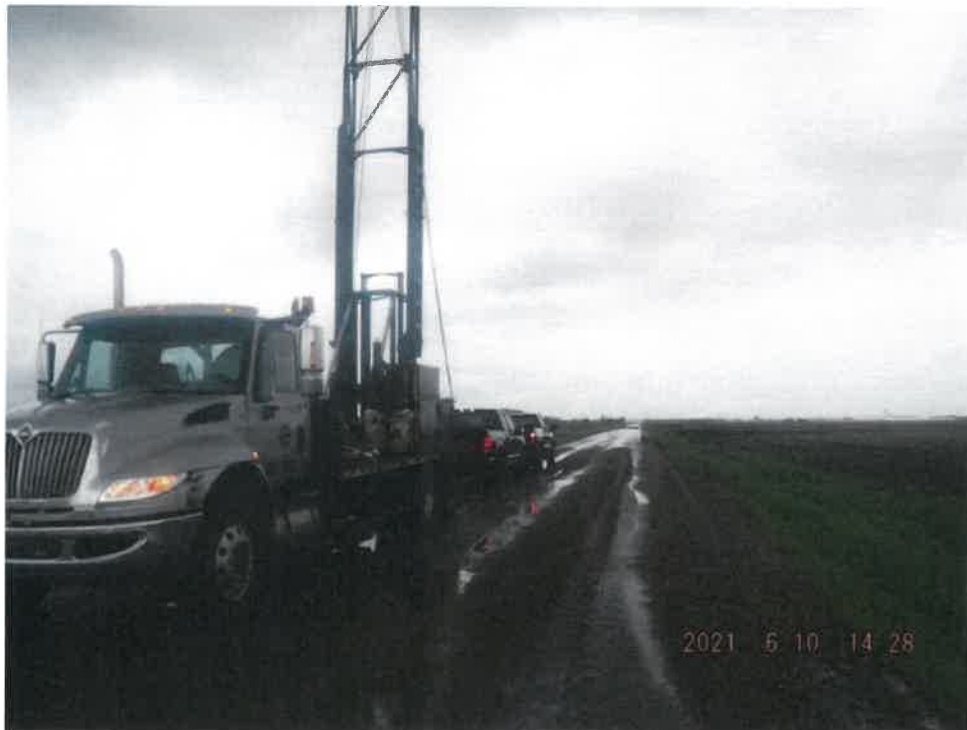
**Photograph 21: Looking east towards BH21-09A within Alignment 9**

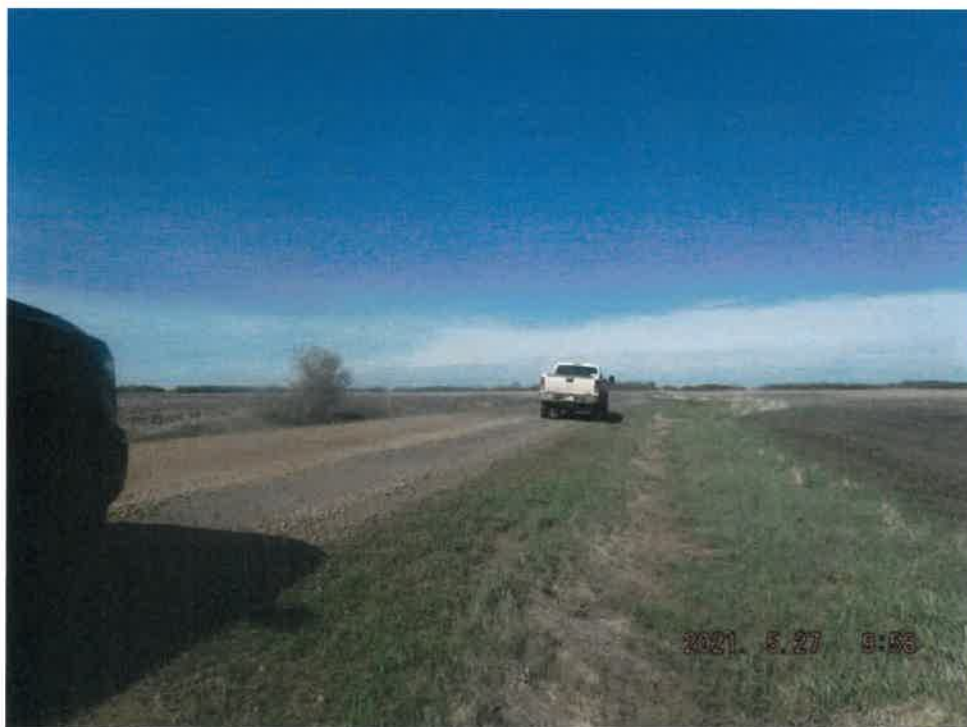
**Photograph 22: Looking north along Alignment 9**

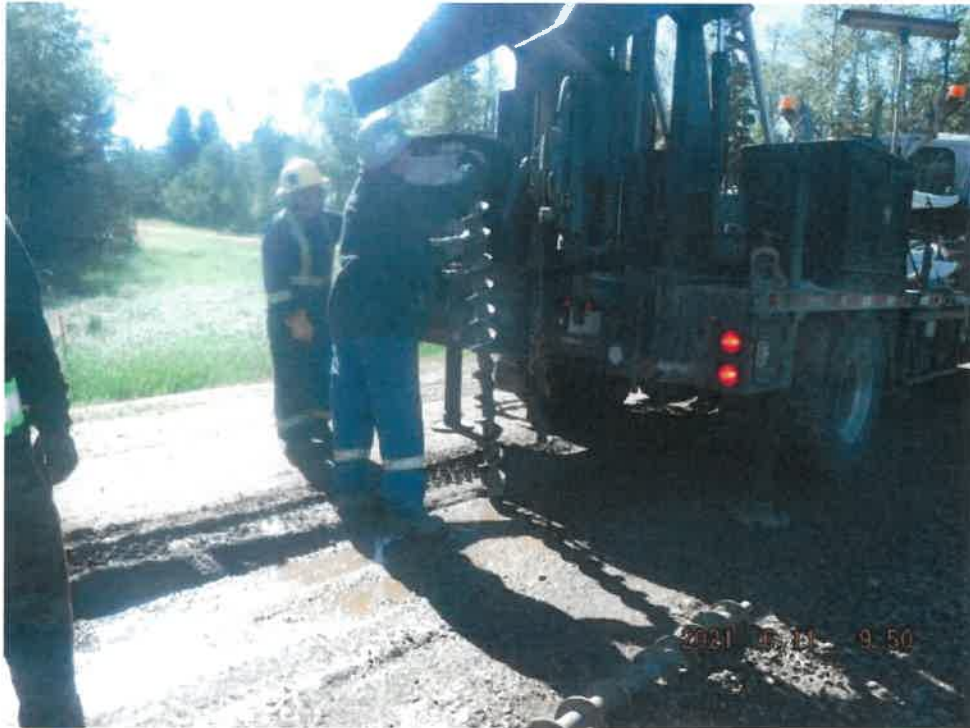
**Photograph 23: Looking south towards BH21-10B within Alignment 10**

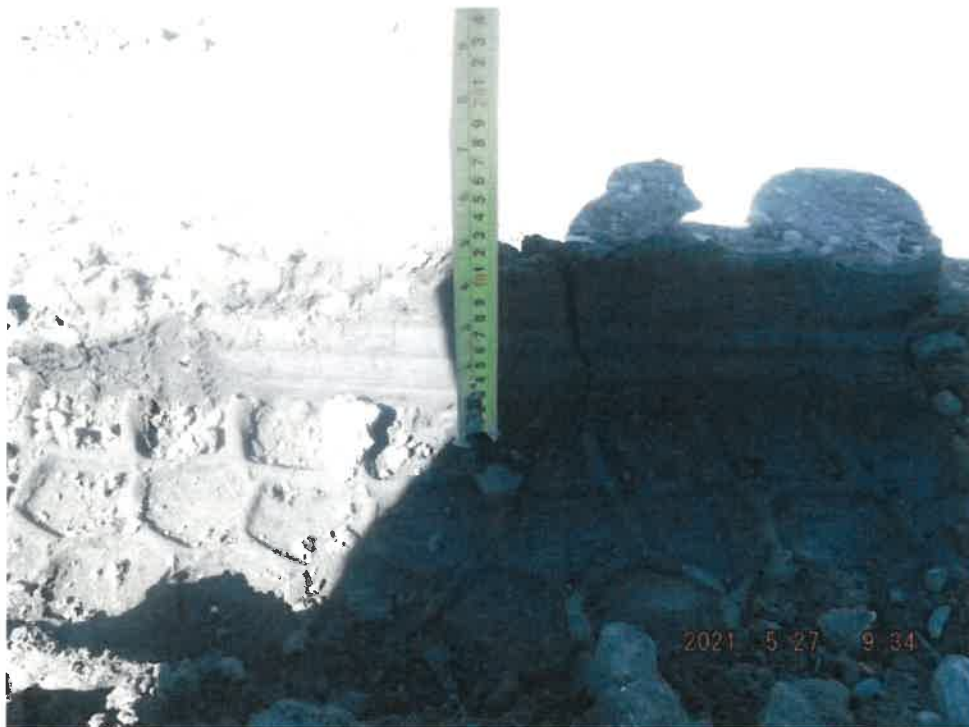
**Photograph 24: Looking at the ruts within Alignment 10**

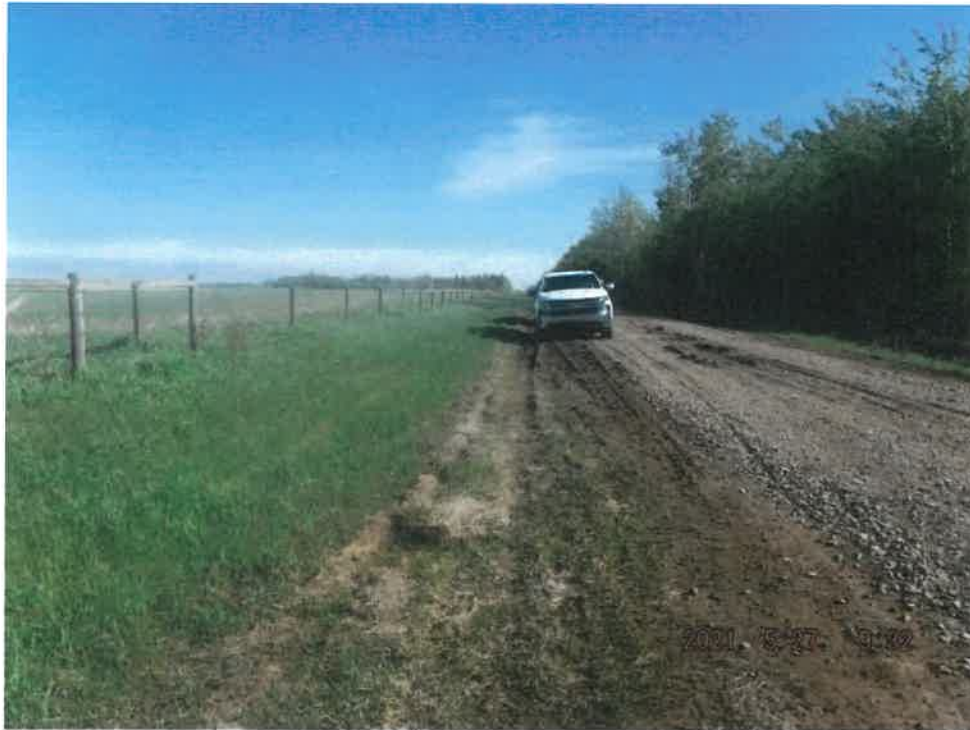
**Photograph 25: Looking north along Alignment 10**

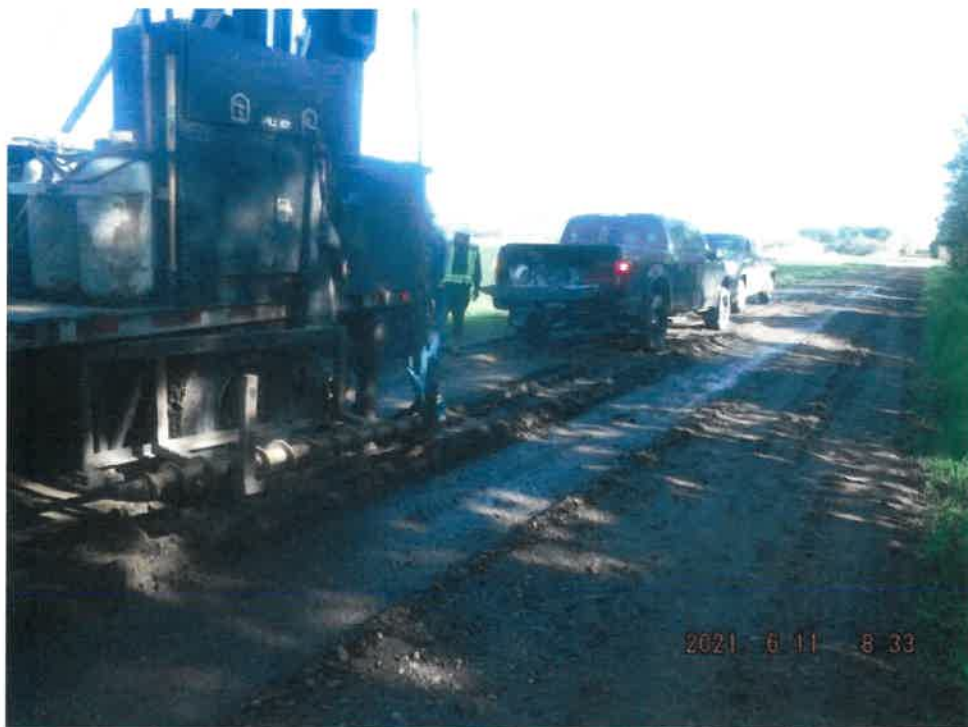
**Photograph 26: Ruts within BH21-11A within Alignment 11**

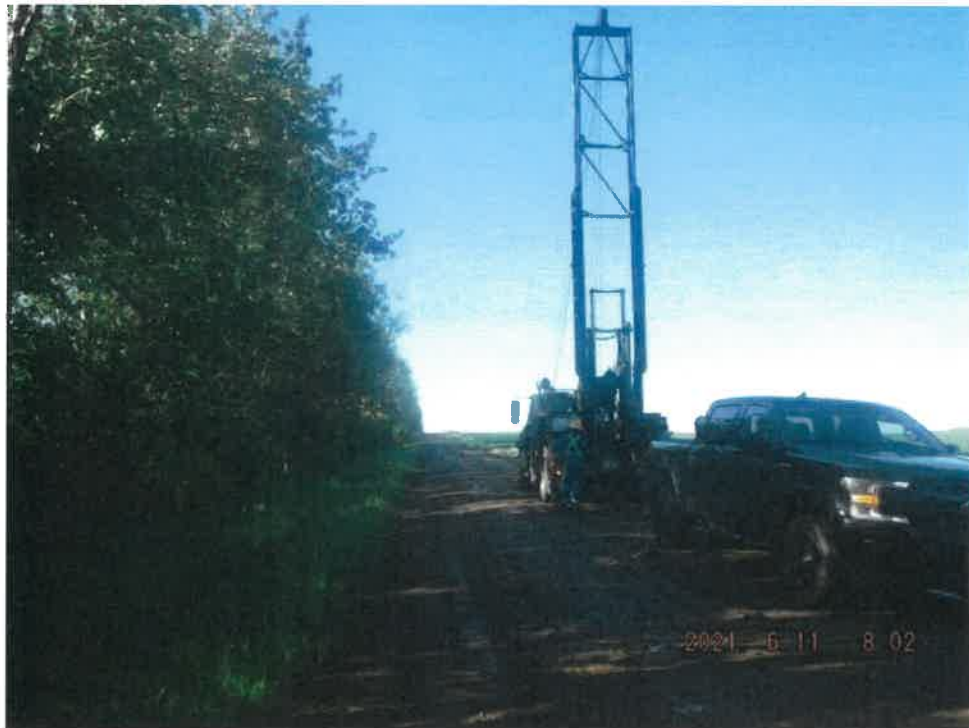
**Photograph 27: Looking south towards BH21-11C within Alignment 11**

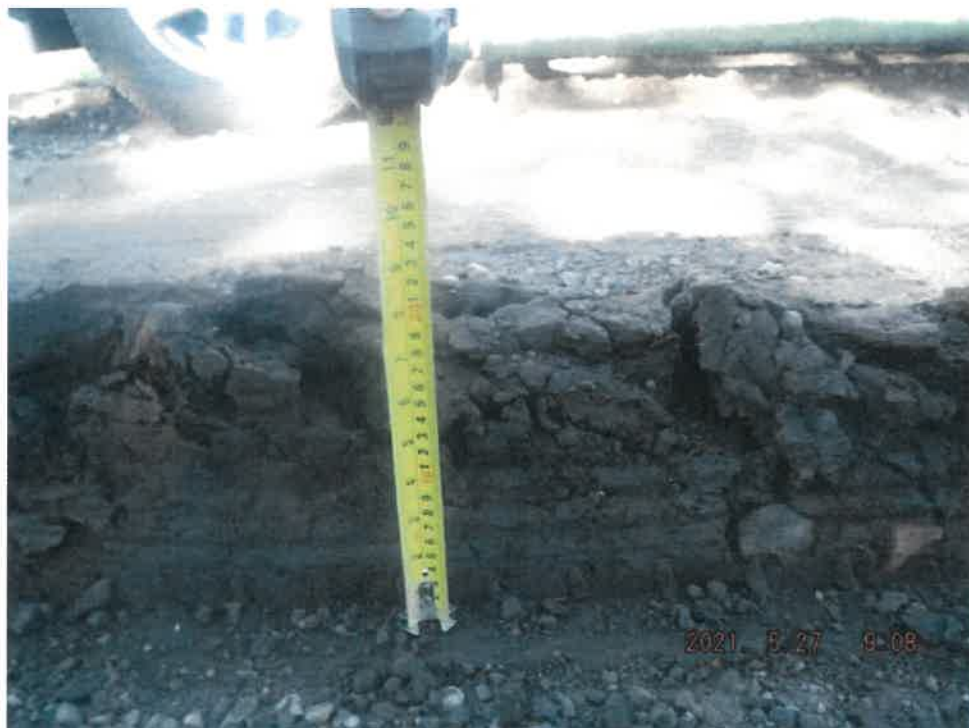
**Photograph 28: Thick ruts within Alignment 11**

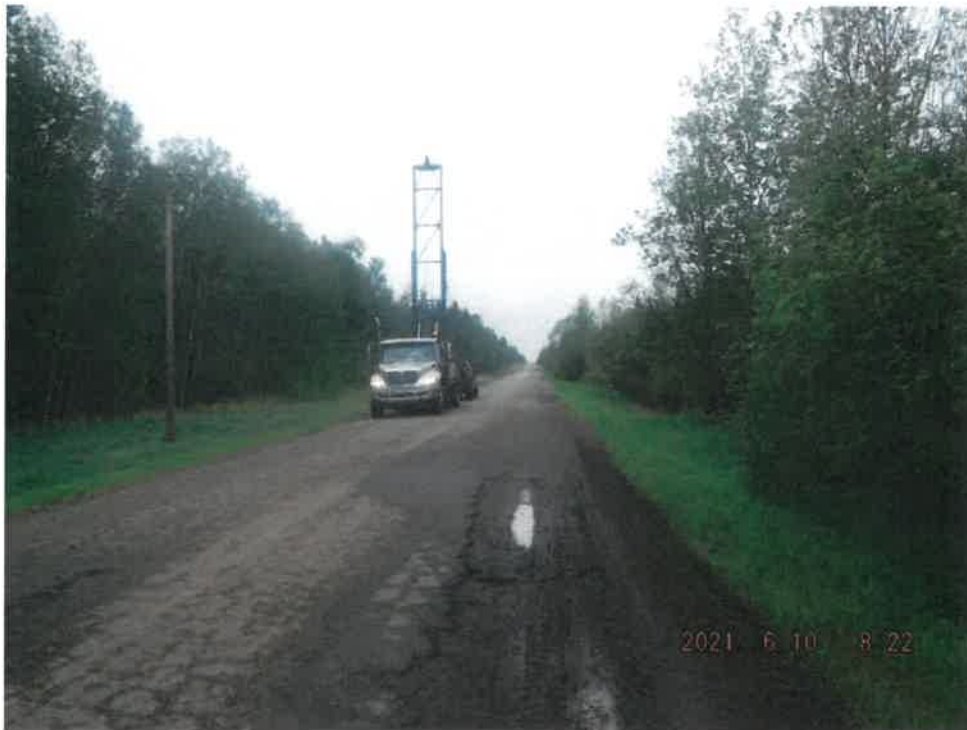
**Photograph 29: Looking south towards BH21-12A within Alignment 12**

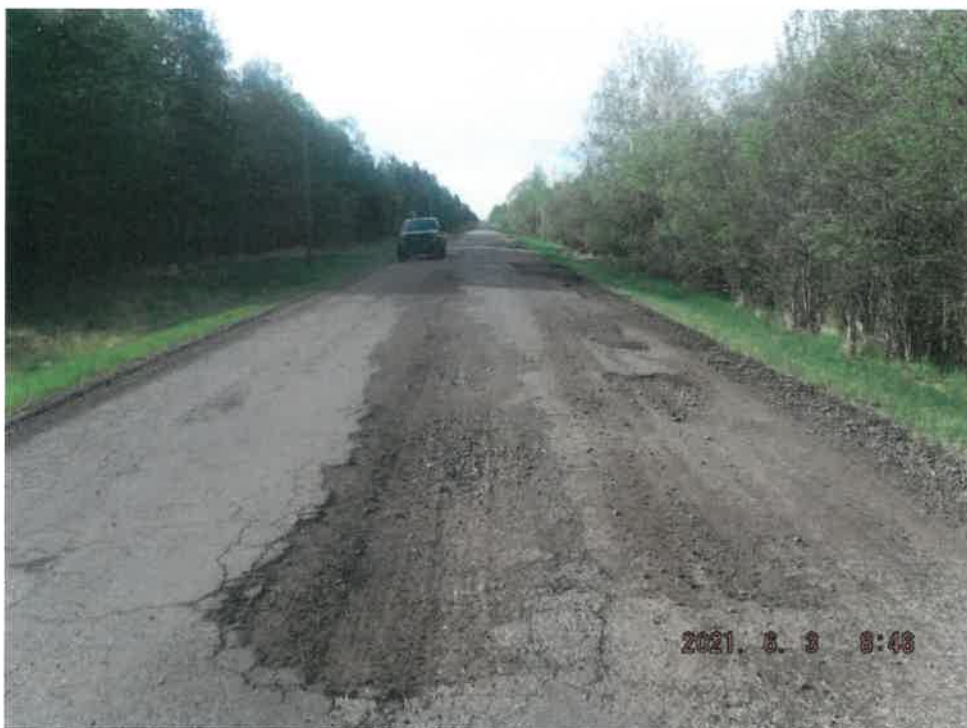
**Photograph 30: Looking south along Alignment 12**

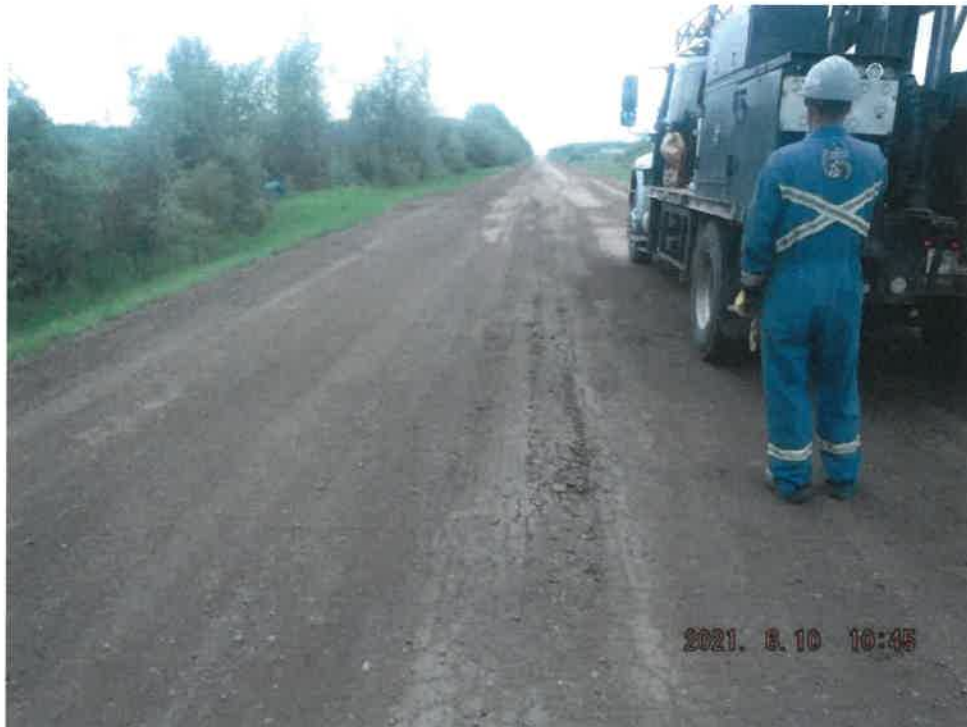
**Photograph 31: Looking north towards BH21-13B within Alignment 13**

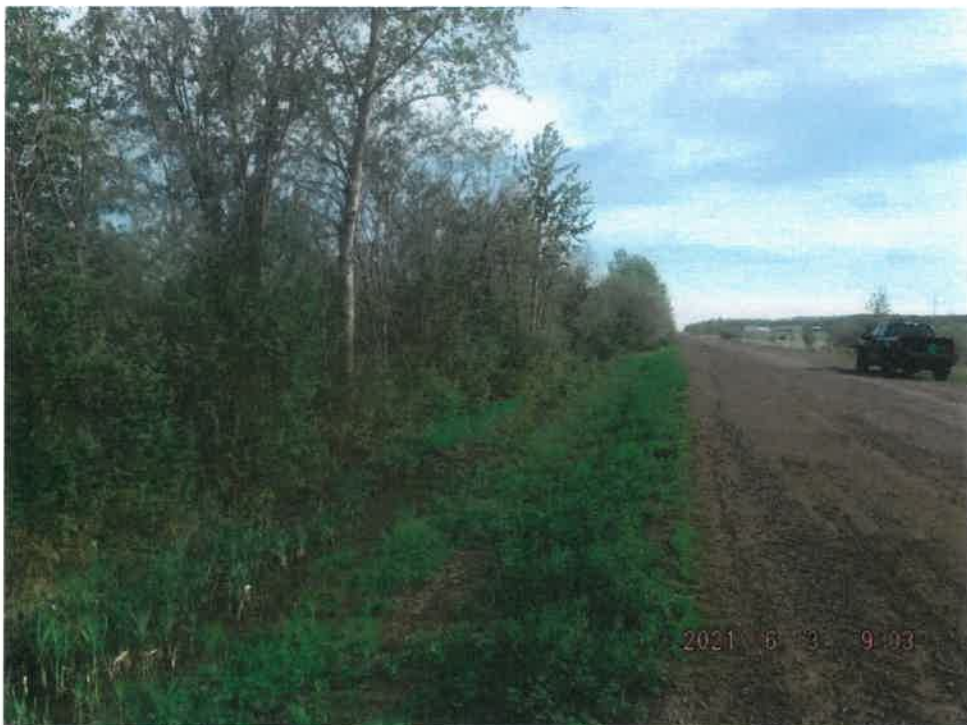
**Photograph 32: Looking at the west ditch along Alignment 13**
