## SMOKY LAKE COUNTY

**A G E N D A:** County Council Budget Meeting to be held on  
**Thursday, September 15<sup>th</sup>, 2021, at 9:00 A.M.,**  
in the County Council Chambers, Smoky Lake.

**Various County Road Failures  
Smoky Lake County, Alberta**

This report presents the results of the geotechnical investigation conducted for various county road failures within Smoky Lake County, Alberta. The work was carried out by SolidEarth Geotechnical Inc. (SolidEarth) at the authorization of Mr. Gene Sobolewski (CAO), C.E.T. of Smoky Lake County (County).

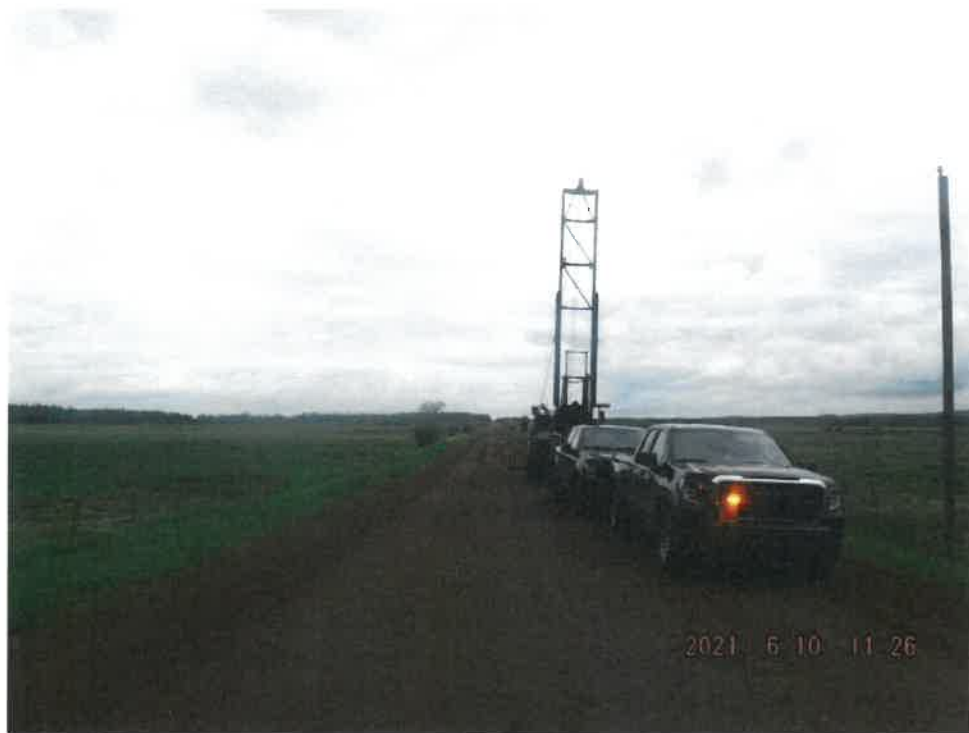
**Photograph 33: Looking north towards BH21-14A within Alignment 14**
