## SMOKY LAKE COUNTY

**A G E N D A:** County Council Budget Meeting to be held on  
**Thursday, September 15<sup>th</sup>, 2021, at 9:00 A.M.,**  
in the County Council Chambers, Smoky Lake.

**Various County Road Failures  
Smoky Lake County, Alberta**

This report presents the results of the geotechnical investigation conducted for various county road failures within Smoky Lake County, Alberta. The work was carried out by SolidEarth Geotechnical Inc. (SolidEarth) at the authorization of Mr. Gene Sobolewski (CAO), C.E.T. of Smoky Lake County (County).

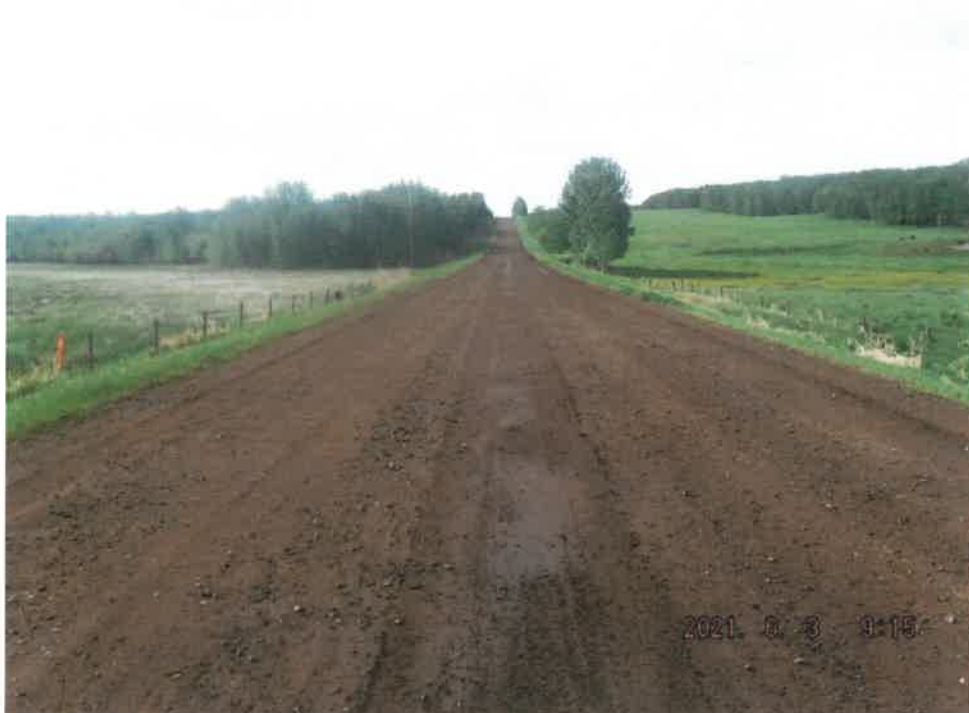
**Photograph 34: Looking south along Alignment 14**
